Manhole Inspection Summary

Manhole # S69M__012MH

Insp Date: 1/31/08 1:22 PM

Location Address: **1100 Steelton Ave.**

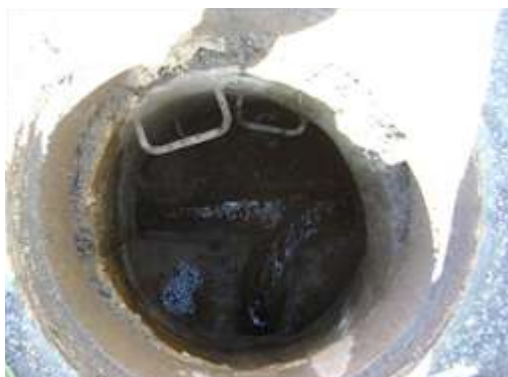
Defect 2

Offset: **2** (in.)

Condition: ☐ Sound ☒ **Cracked** ☐ Leaks

Offset frame defect

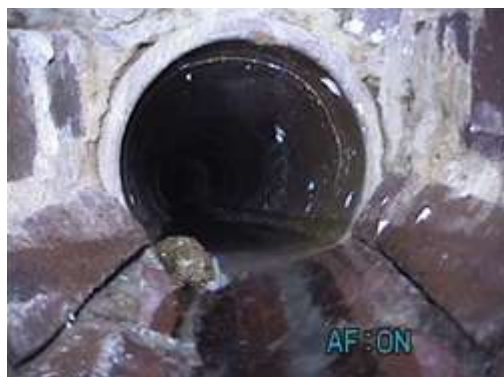
Defect 1

Comments **BOTTOM OF CHANNEL IS DROPPING OUT.**

Mortar missing in channel. Bottom of channel dropping out. incoming 3 O'Clock

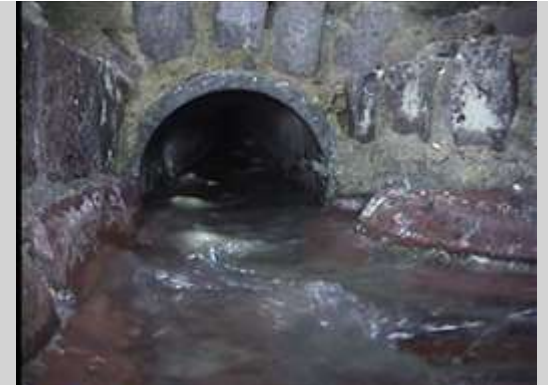
12 O'Clock Outflow

Pipe Height: **8.4** (in.) Rod and Bar (Angled)
Pipe Material: **Clay** ☐ Pipe Lined
Invert Depth: **7.67** (ft.) Flow Characteristics: **Fast**
Deposits: ☐ None ☐ Mud ☒ Sludge ☒ Debris ☐ Grease
Silt Depth: **0.5** (in.) Deposits Extent: **Light**
Infiltration: **None** Pipe Seal Cond: **Sound**
